**LTPP Seasonal Monitoring
Program**
Site Monitoring Suspension
Status Report
Section 421606
Altoona, Pennsylvania

SEASONAL MONITORING PROGRAM SUSPENSION STATUS REPORT

PENNSYLVANIA SECTION 421606

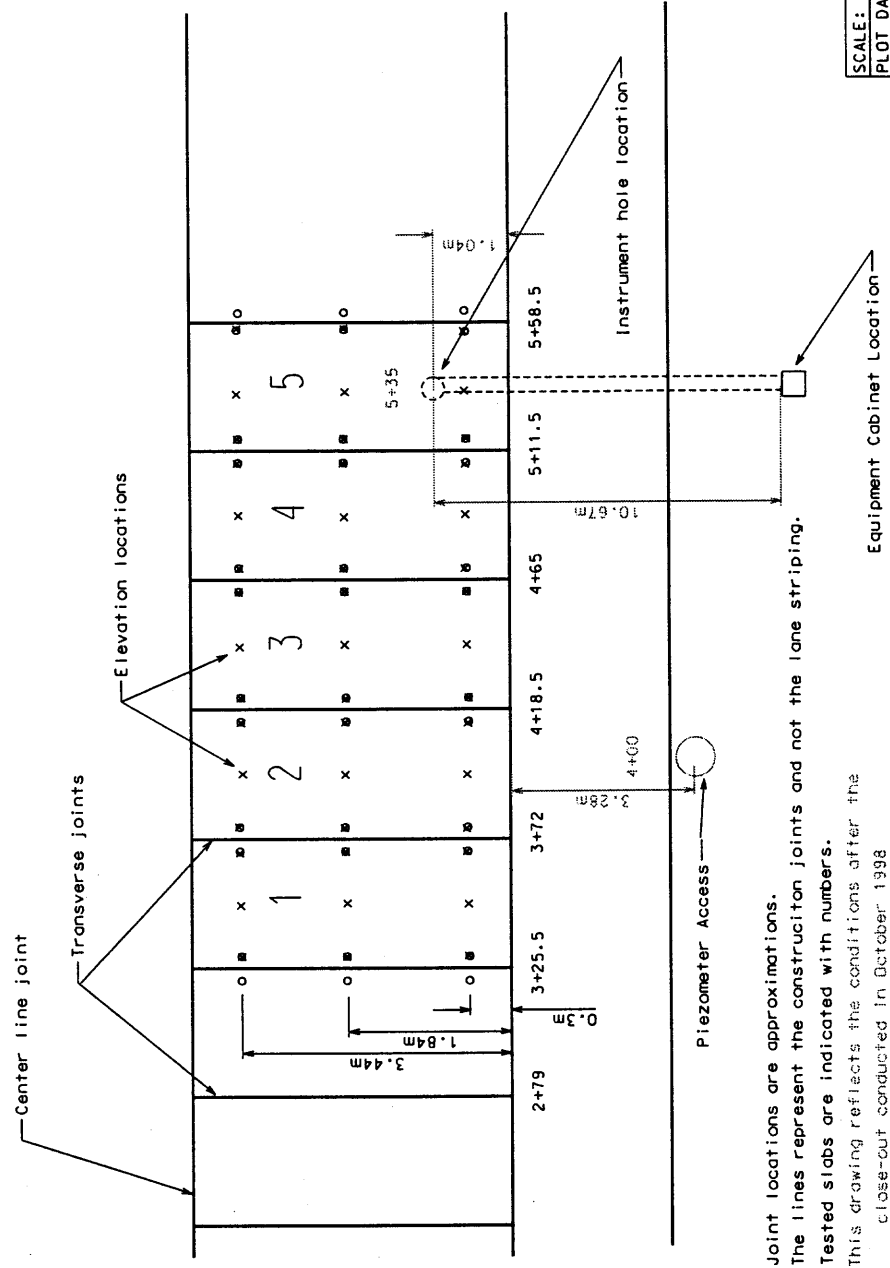
Figure 1. Plan view of Section 421606 - Post Suspension

Figure 1 shows the locations of the installed instrumentation at the site. The instrumentation hole is at Station 5+35 and the piezometer is at Station 4+00. Table 3 gives elevations of the portion of test section 421606 that was used for elevation measurements. All offsets are measured from the outside pavement edge at the pavement shoulder interface.

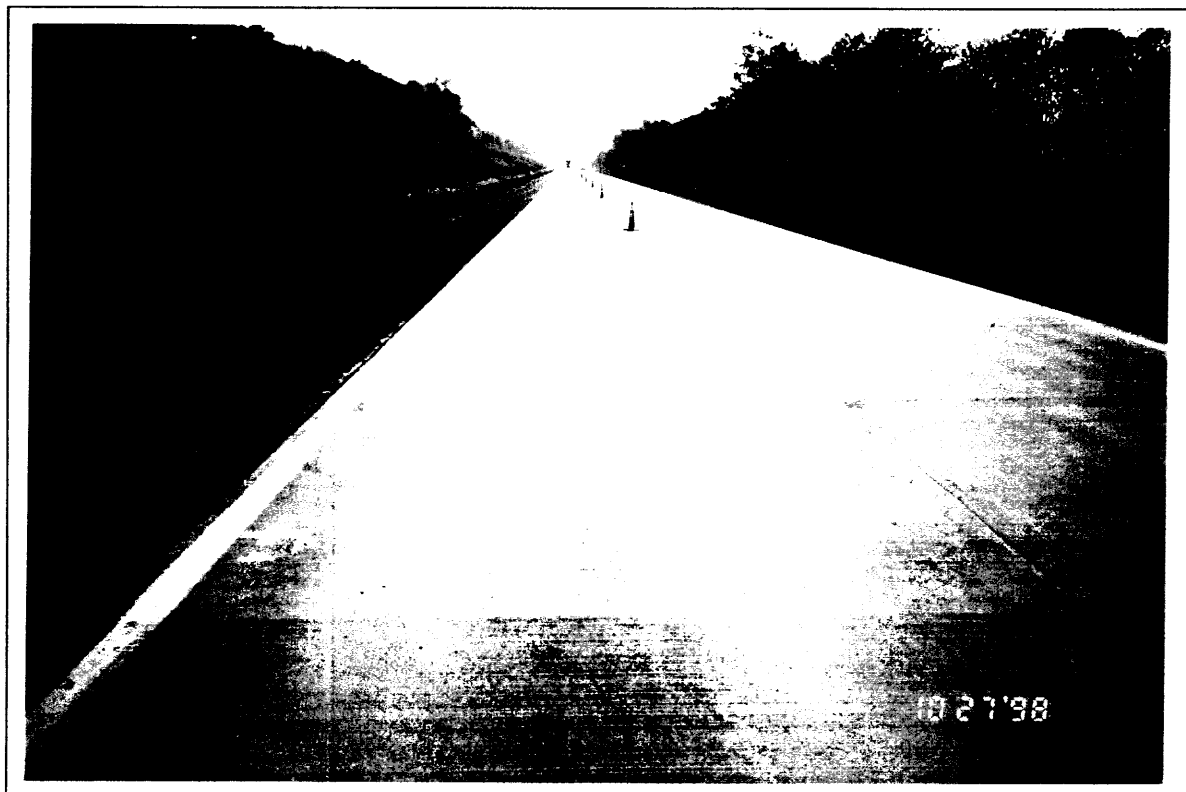
The suspension preparation activities at site 421606 were conducted during the final site visit on October 27, 1998. A manual distress survey of the entire section was conducted on September 17, 1998. The site location exhibits slight to moderate transverse cracking, some minor polishing in the wheel path. Over the entire surface, there is some minor cracking/spalling; possibly silica reactive aggregate. The site paint markings were refreshed in conjunction with the MDS survey. On this day, two sets of FWD tests, one set of elevations, joint opening measurements, joint faulting measurements, and a distress survey of the instrumentation area were conducted. The water table measurements and the manual resistivity measurements (2 and 4 point) were performed in the morning and afternoon. The Onsite datalogger was downloaded before being dismantled. Two sets of TDR traces and resistance voltages were extracted by the mobile datalogger. The snap ring holes were cleaned and sprayed with graphite grease. The trench from the instrument hole to pavement edge were patched with 'quickcrete' fast-setting concrete. A more permanent patch should be done in this area (i.e. remove and replace material).

Pavement Condition, Seasonal Site 421606, October 1998, During Suspension Activities

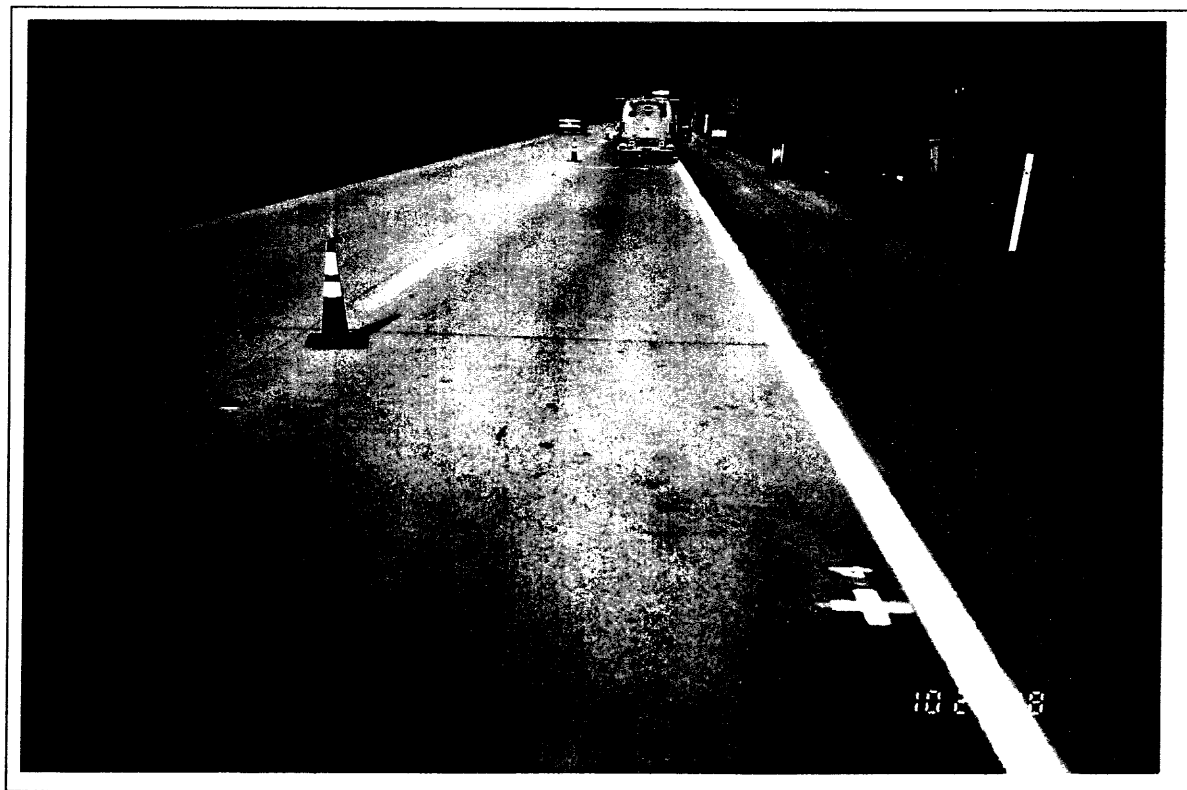
Pavement Condition, Seasonal Site 421606, October 1998, During Suspension Activities

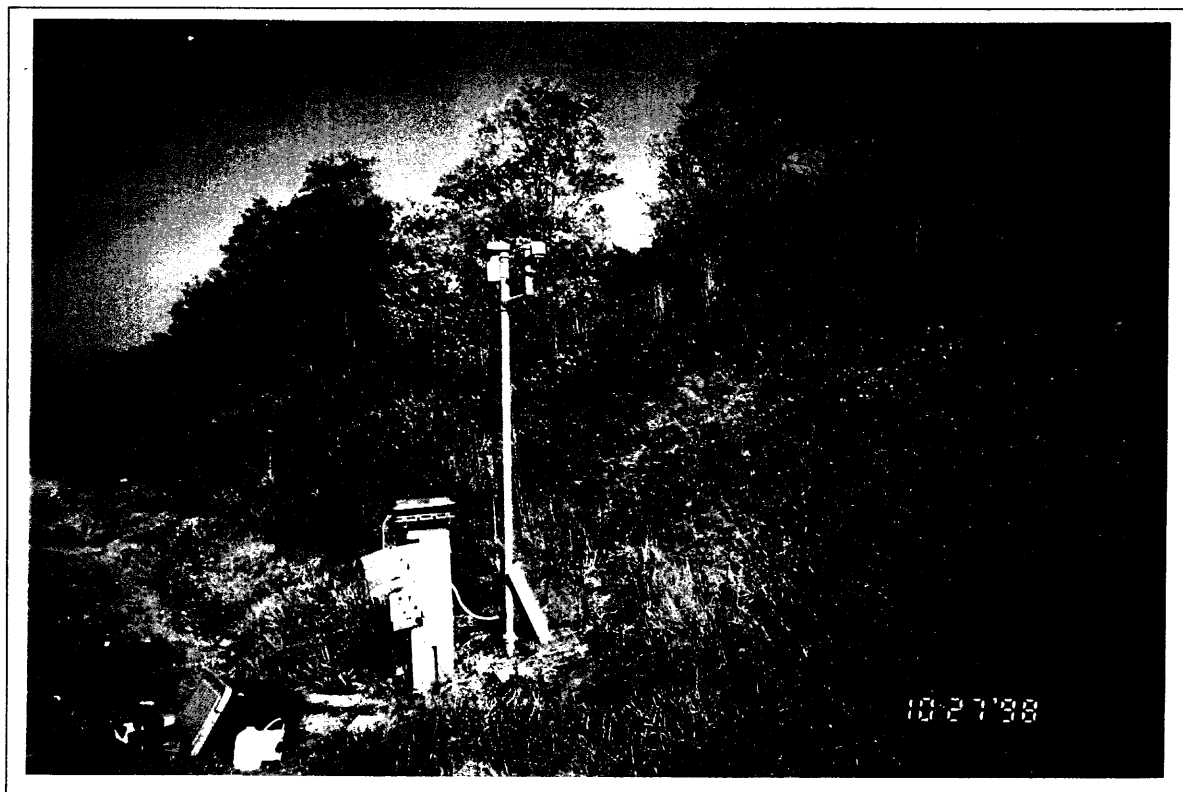
Instrumentation Location, Seasonal Site 421606, October 1998, During Suspension Activities

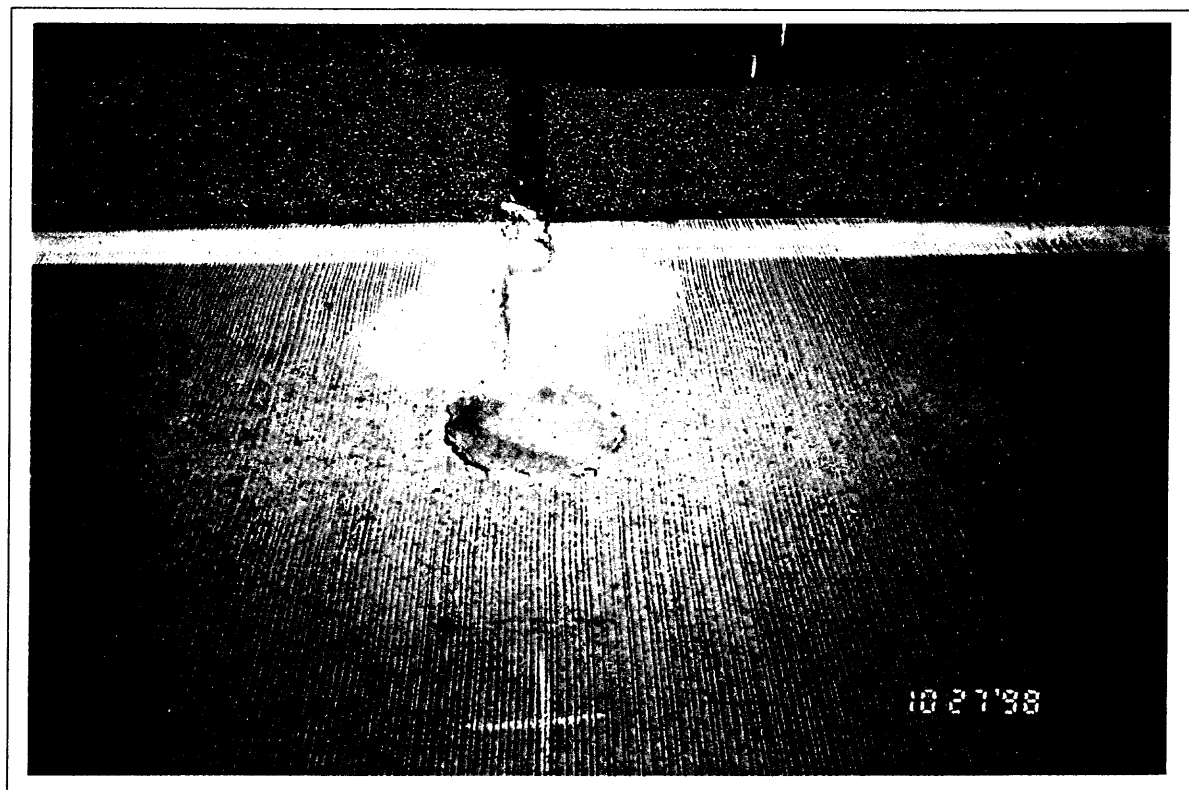
Instrument Hole, Seasonal Site 421606, October 1998, After Suspension Activities

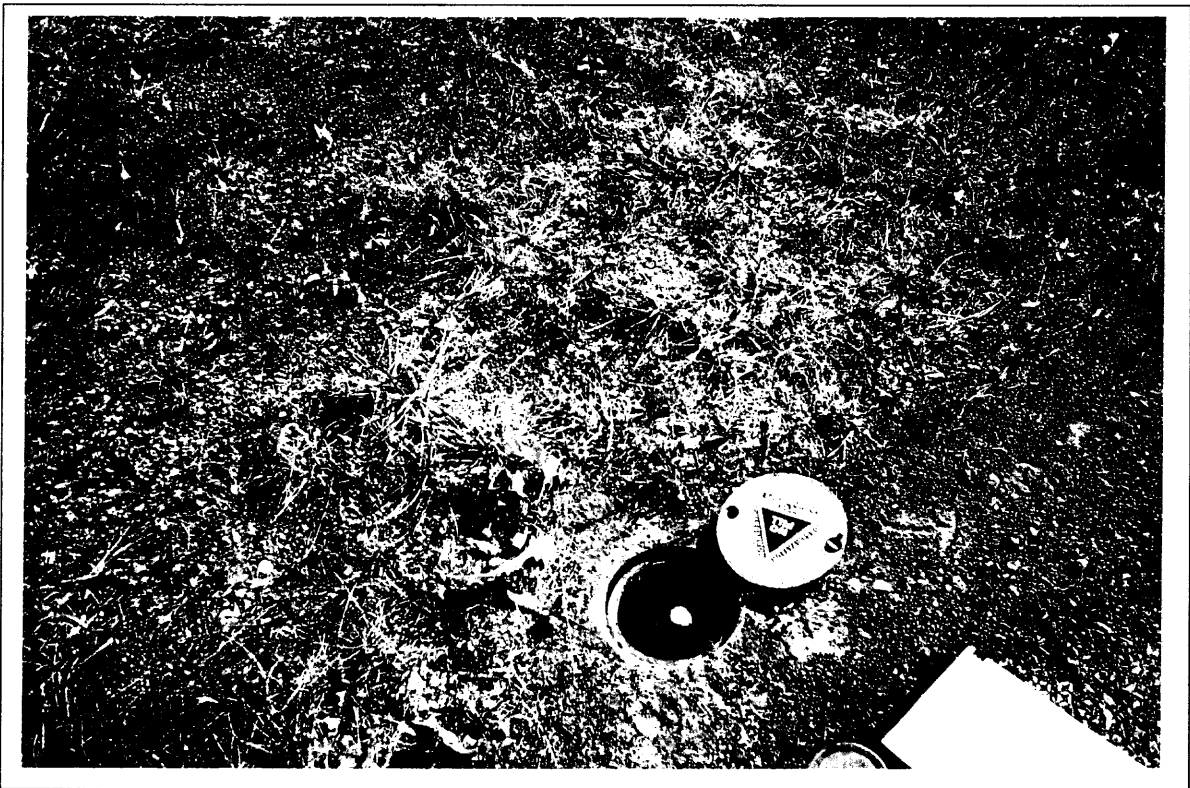
Piezometer Location, Seasonal Site 421606, October 1998, During Suspension Activities
